MAJOR REHABILITATION PROJECT
SAGAMORE HIGHWAY BRIDGE
CAPE COD CANAL
BOURNE, MASSACHUSETTS

RECONNAISSANCE REPORT

JULY 1977

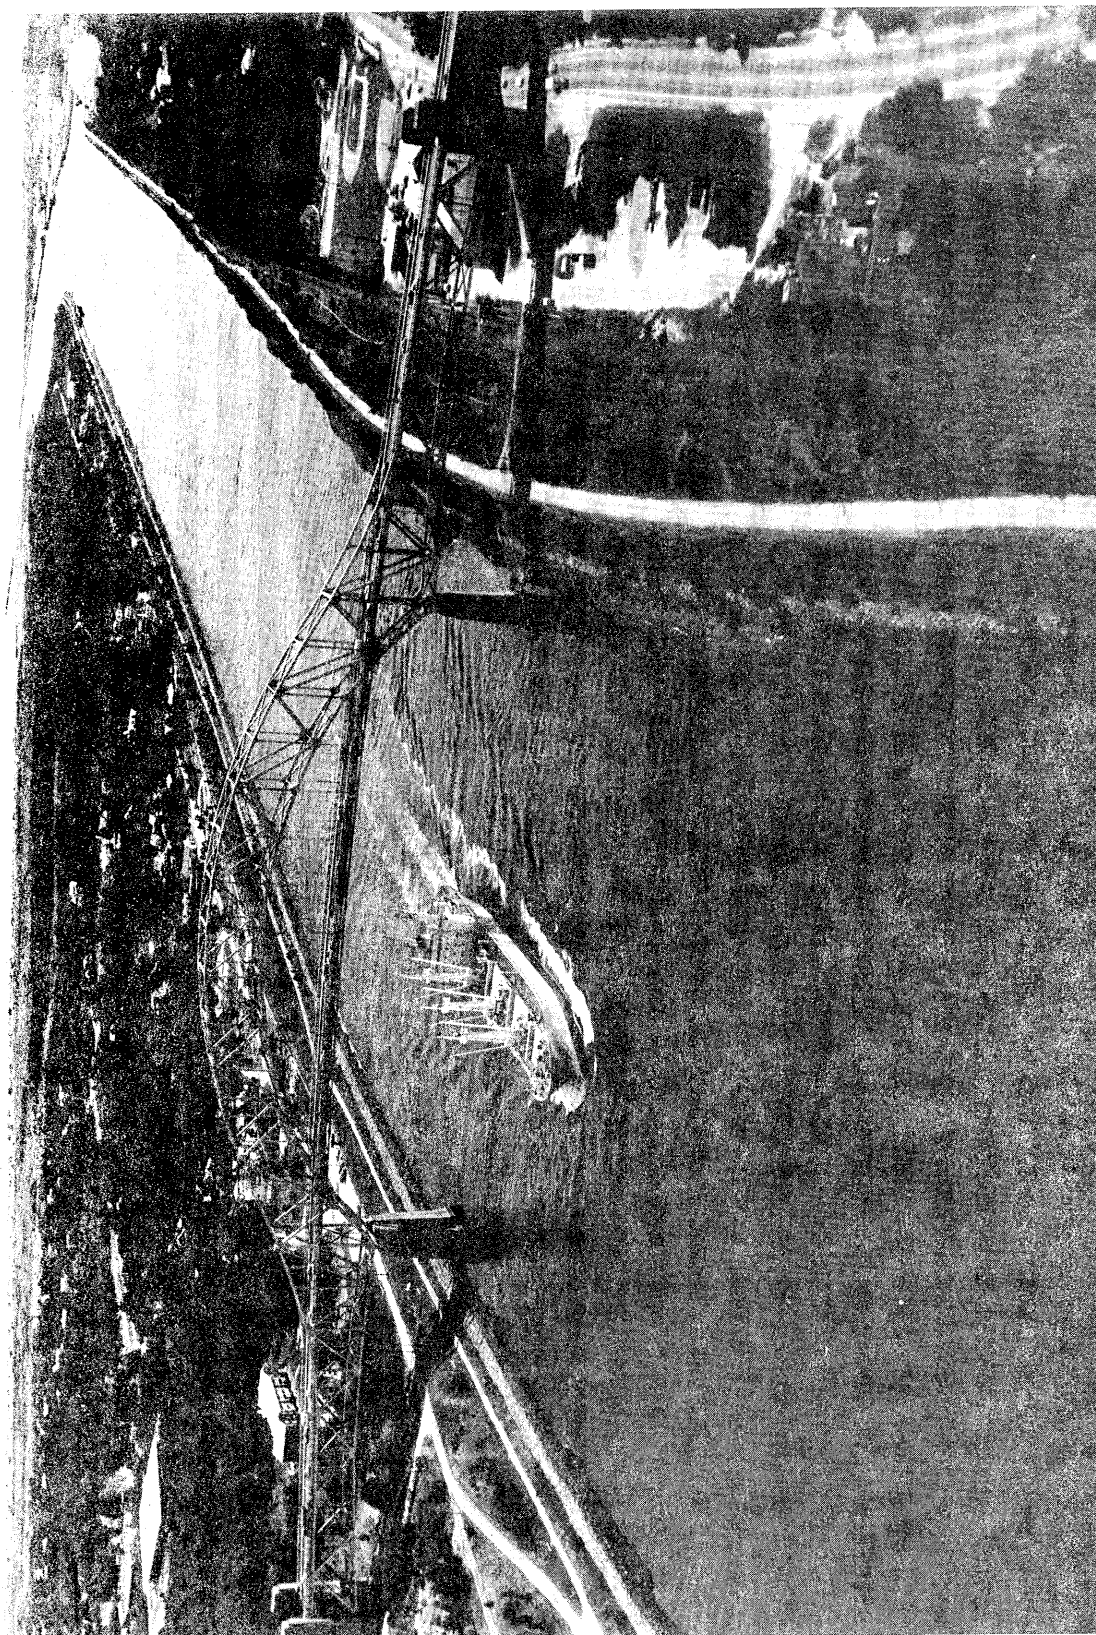
FIG. 3

e. Cable Hangers. The cable hangers which support the suspended roadway of the main span were the subject of intensive investigation and testing. The pairs of cables at panel points 14'W and 15'E (See Figure 3) were removed and replaced with new cables. The removed cables were subjected to physical and metallurgical testing to determine their strength and probable remaining life. The results of the investigations are contained in a report titled; "Sagamore and Bourne Highway Bridges-Suspender Cables-1976 Condition Report." In summary, the conclusions of that report state that the tested cables still possess the originally specified strength and that the galvanized coating has started to break down. The report further states that it will be 10 to 15 years before extensive corrosion may be expected to occur. Continued regular inspection is recommended in order to detect accelerating corrosion and certain maintenance procedures are outlined. Eventual replacement of the cables is foreseen as no known maintenance program will arrest the deterioration of the galvanized coating at critical locations. The remaining useful life of the cables places them beyond the time frame of projected repairs as recommended in the ER (5 years) and their replacement has not been included in the proposed Rehabilitation Project.
